Prehistoric Cypriot Mud Buildings and their Impact on the Formation of Archaeological Sites.

Thesis submitted for the degree of PhD.

Department of Archaeology.

University of Edinburgh.

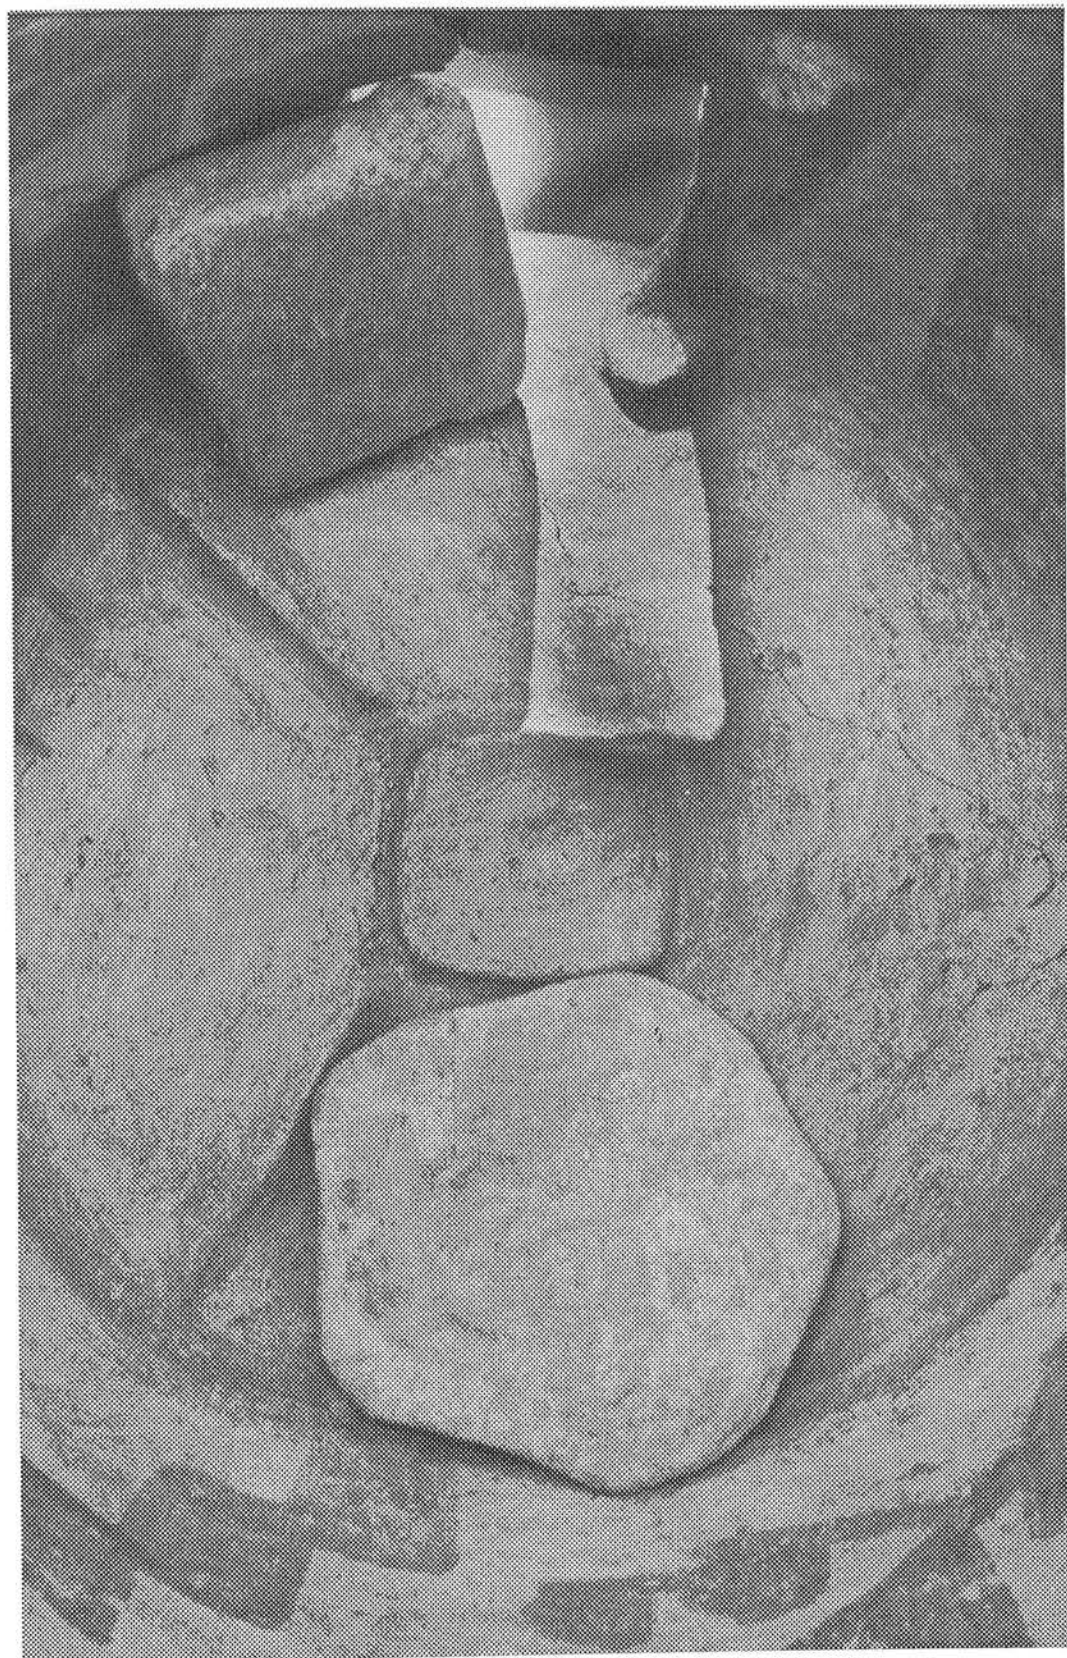
Fig. 45 Building model KM1446 looking into the vessel showing the hearth, ridges and door.

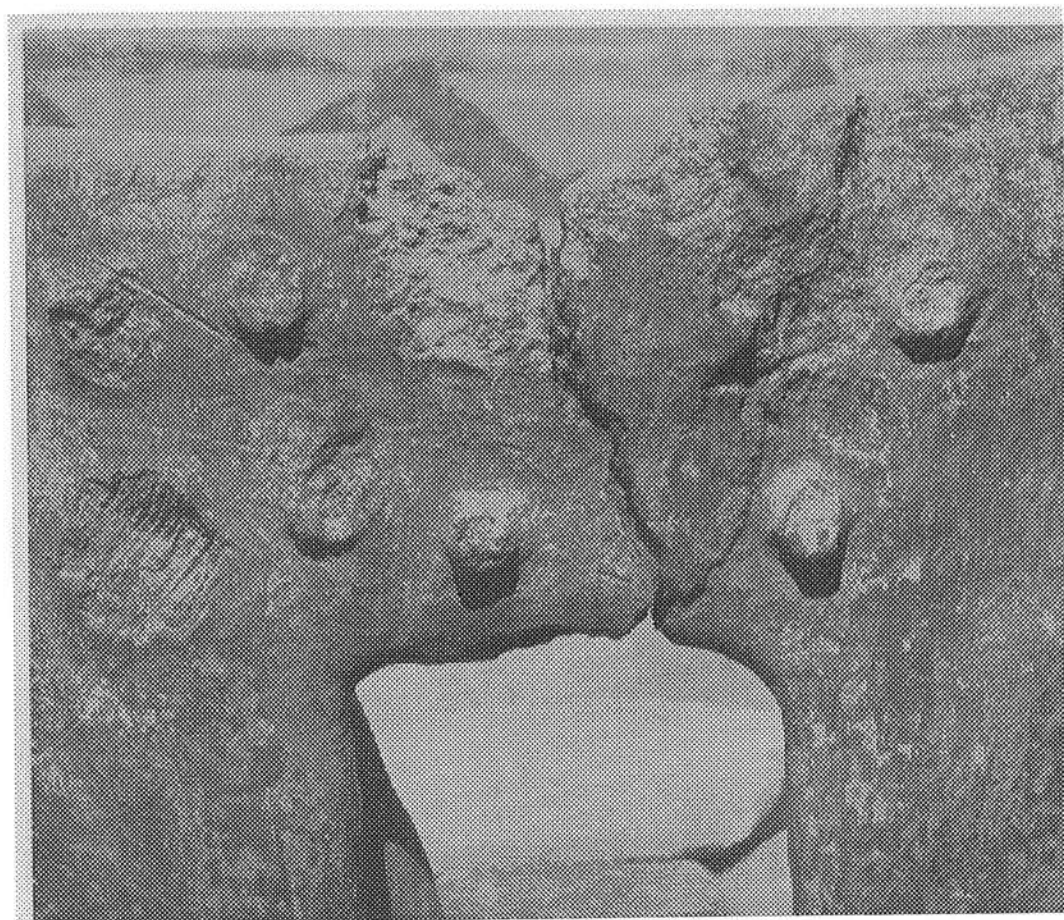
Fig. 46 Building model KM1446 view of the broken tenons above the doorway.

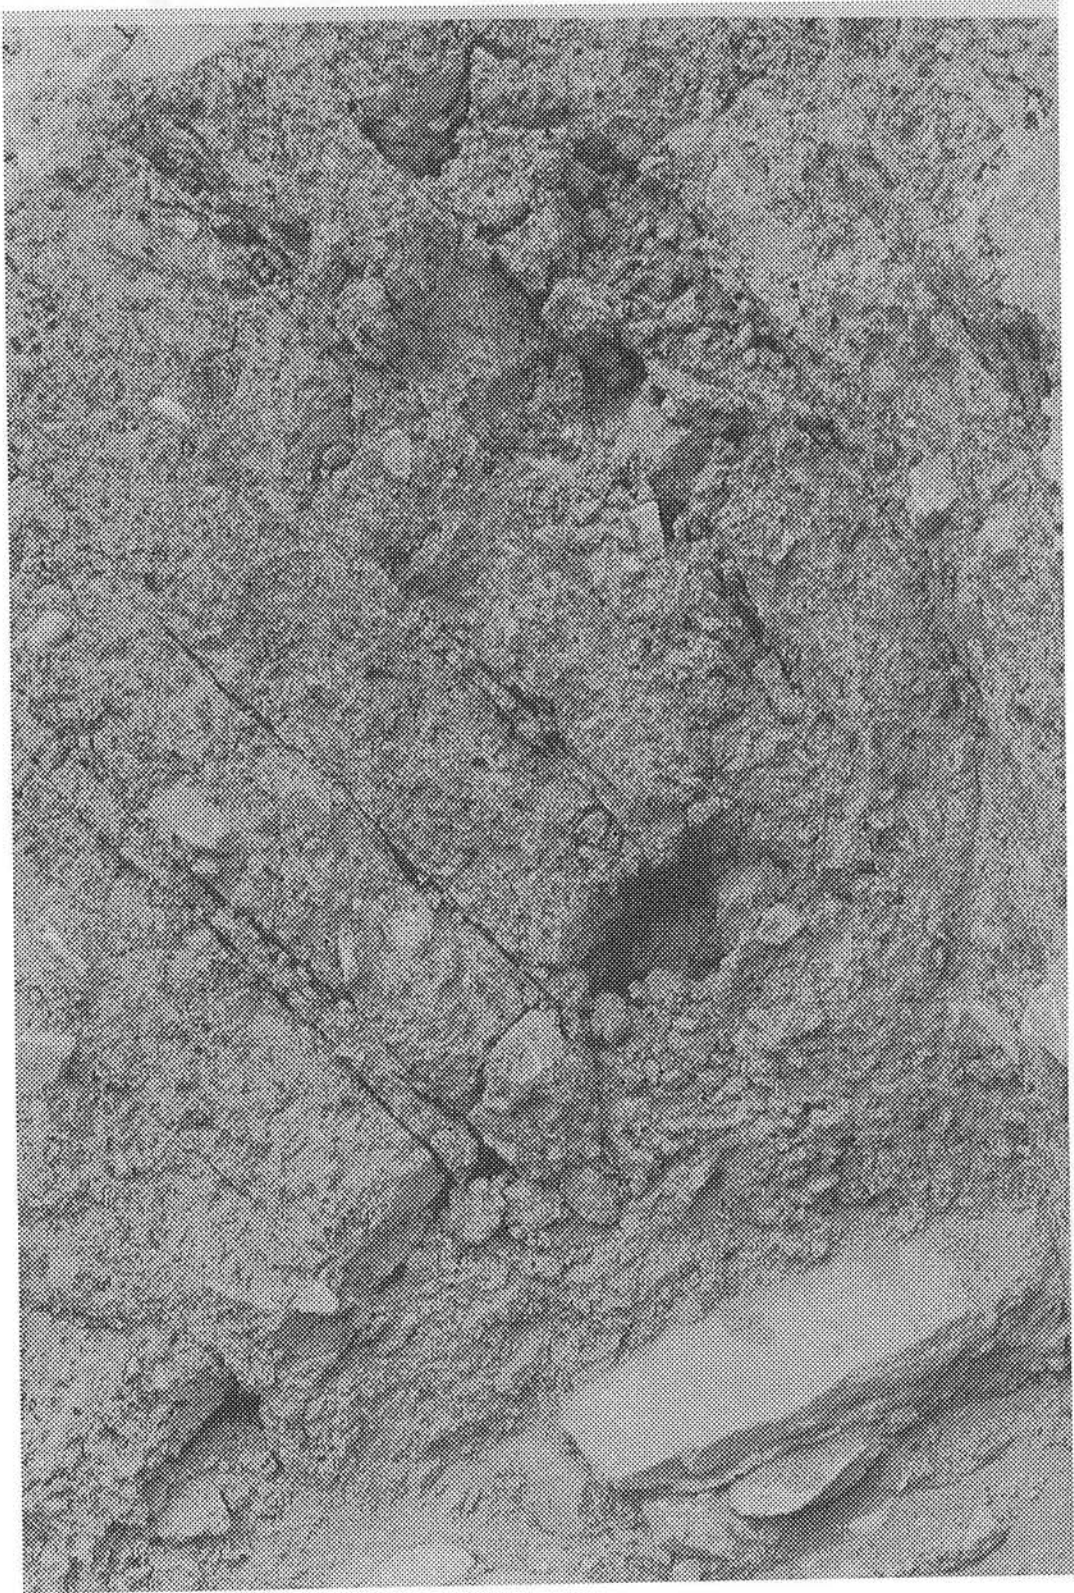
Fig. 59 Collapsed mud brick showing effects of exposure of mortar and brick face to erosion.

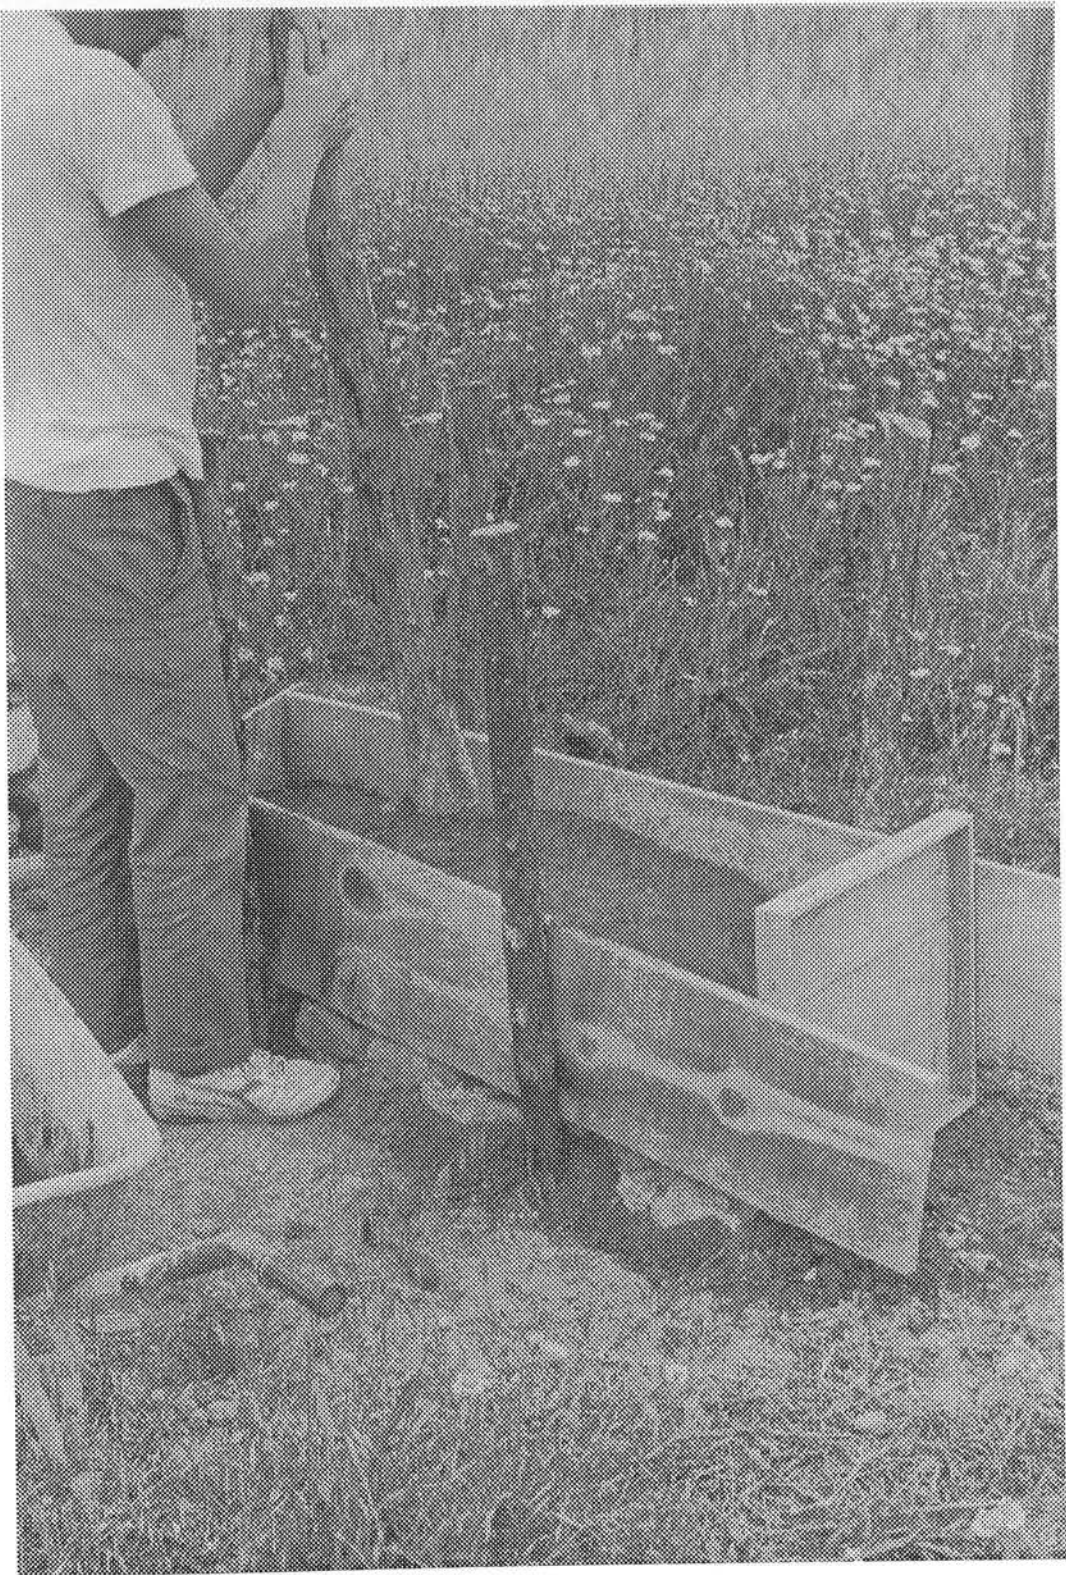
Fig. 67 LEV, experiment E17 showing the construction method in pise.

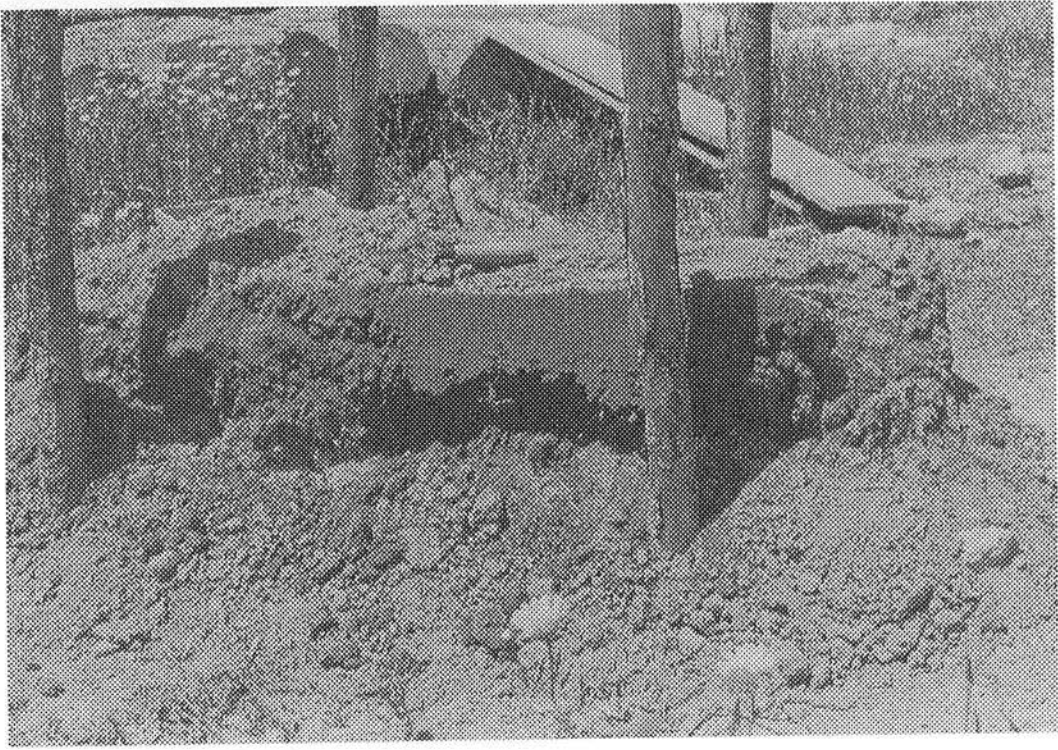
Fig. 69 LEV, experiment E17 after removal of the shutters showing the collapse over the stone footing.

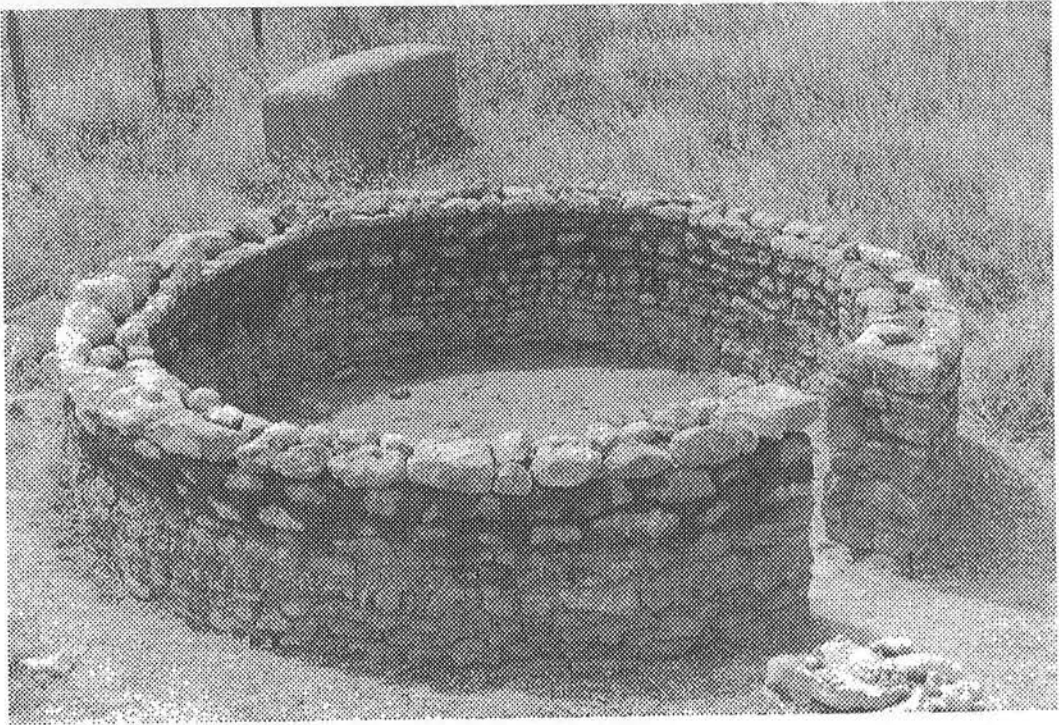
Fig. 94 LEV, RH2 stonewall under construction.

The wall is built in stages upon a foundation of stone which serves to raise the mud above the effects of rising groundwater and splashback from rainfall (fig. 66, 106-7). This foundation can be no more than a couple of courses high although local considerations can dictate otherwise. The thickness of the walls usually ranges from 0.45-0.60m and up to 1.0m although the lower range forms the most stable type of structure. Thicker walls have more scope for developing internal stress factors which could ultimately lead to structural weaknesses. Thinner walls are known, for example, in parts of W Africa (Blier 1987), which can be perfectly adequate when applied to lightly roofed single storey structures or compound enclosures. Mud is heaped onto the foundation and manually trodden or handled into position to a height of 0.10-0.60m. Anything higher could not be supported while the mud is in a wet condition (fig. 84). Drying takes anything from one day to one week depending on local weather conditions and is essential in order to prevent cracks developing for the entire height of the wall and to provide a firm platform for the next layer to be added. This continues until the desired height has been achieved with windows and doors being created during construction or cut through the final wall after it is finished and has been allowed to dry out thoroughly. This basic method is applied in almost all parts of the world where mudwall is used. Modern tools and equipment can create a more regular and straighter type of wall but judgement by eye and hand finishing does also produce an effective long lasting wall. The differences are probably more aesthetic rather than practical.

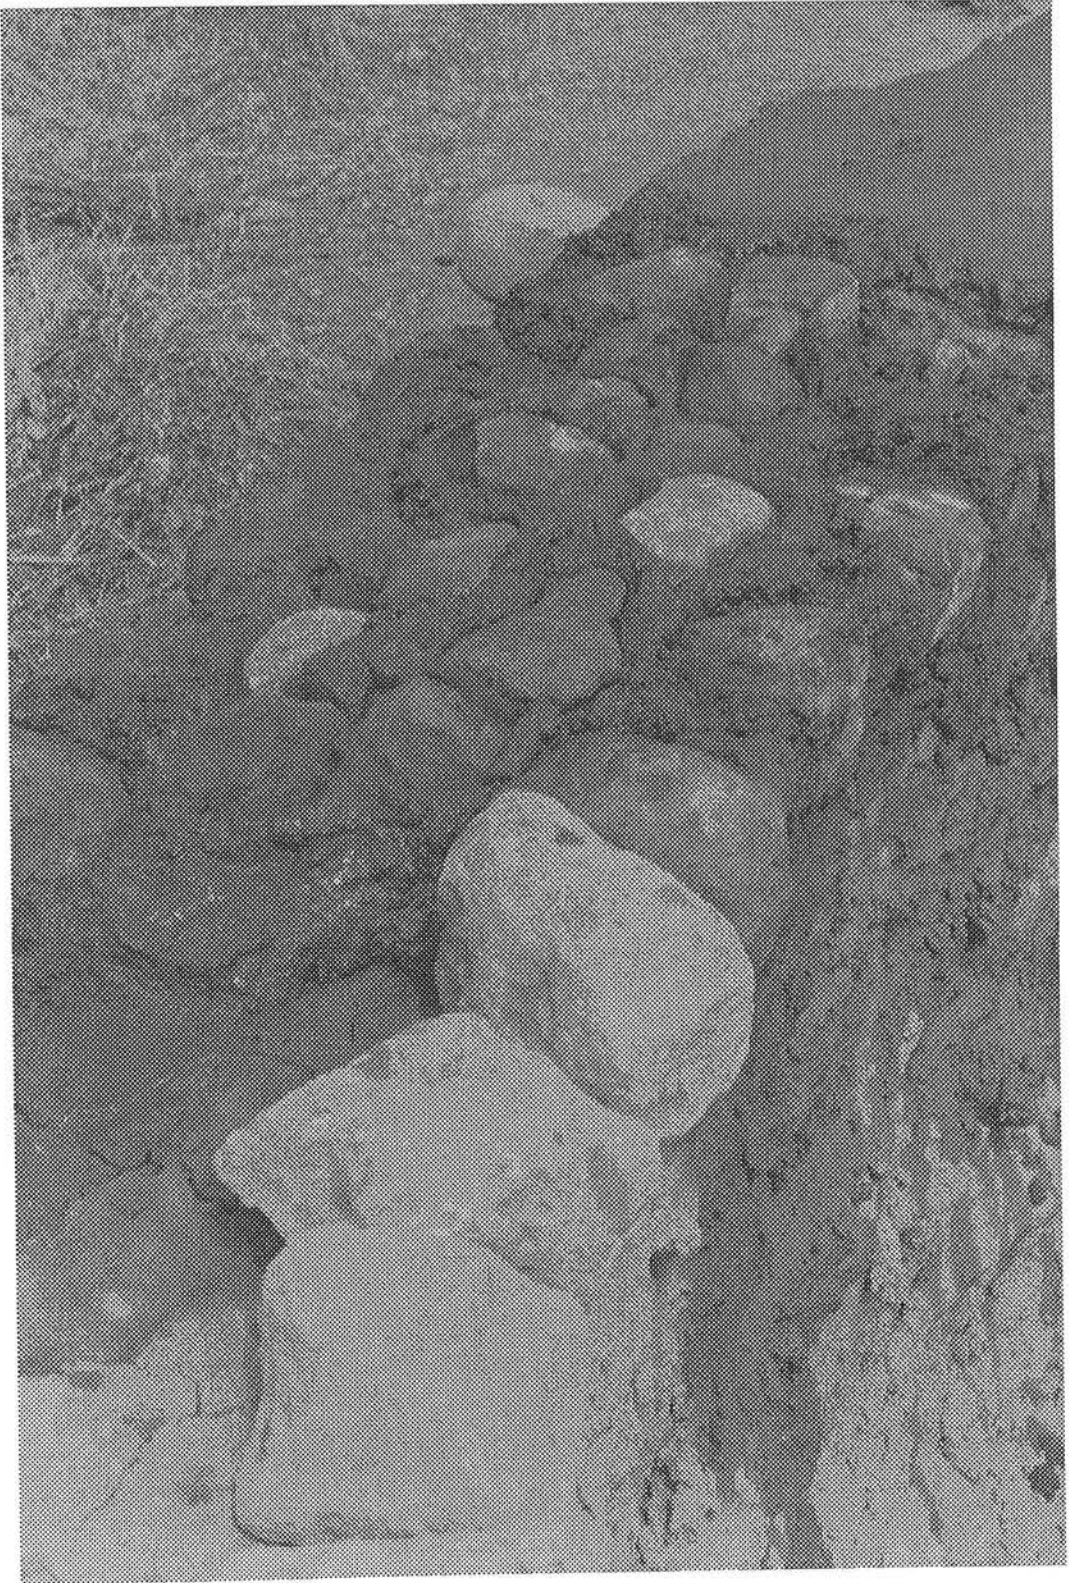
Fig. 95 LEV, RH2 showing method of stonewall construction.

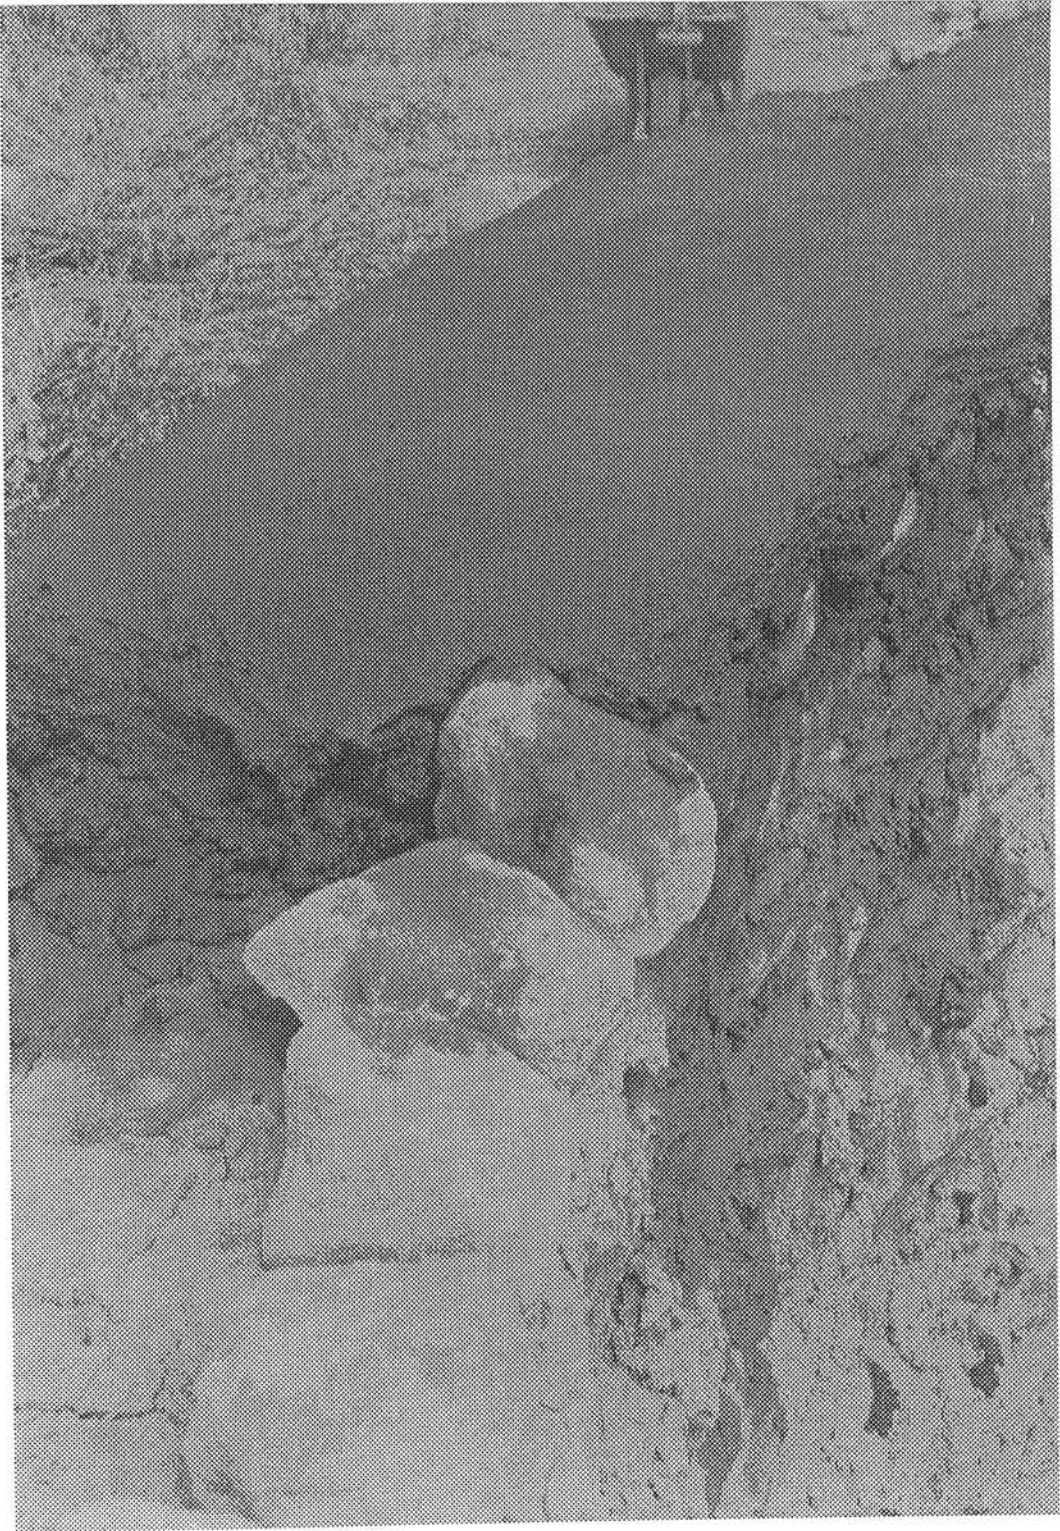
Fig. 96 LEV, RH2 stonewall construction showing the application of a thick mud mortar over the stones.

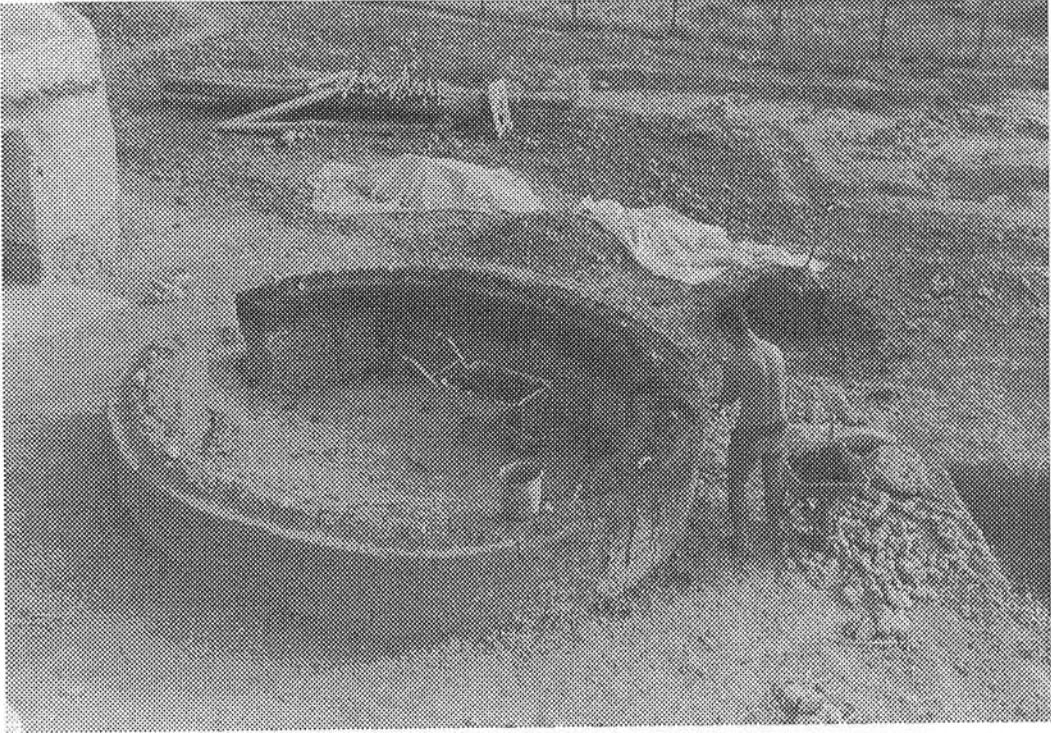
Fig. 106 LEV, RH3 the mudwall under construction.

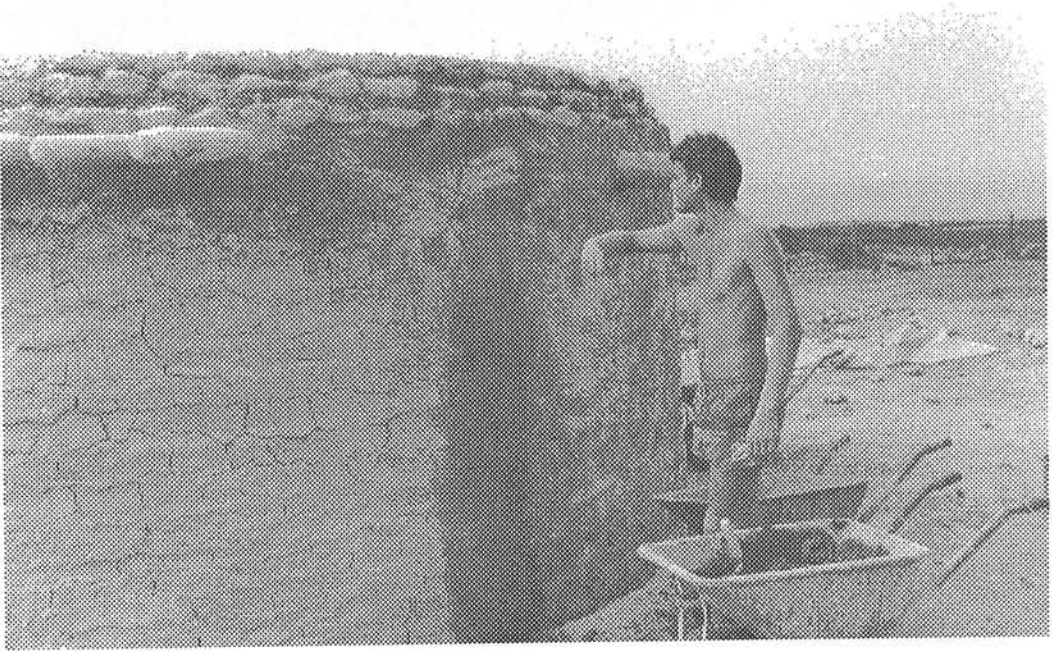
Fig. 112 LEV, RH3 application of havara dusting to render before burnishing.

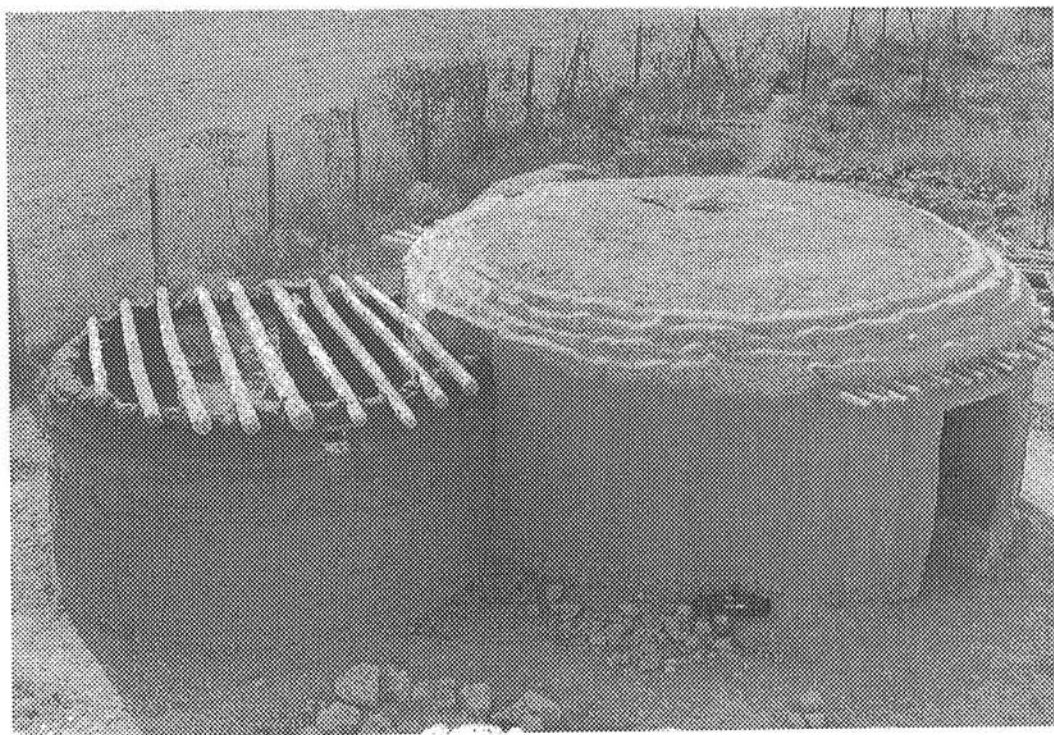
Fig. 115 LEV, RH4 with completed mudwall and rafters in position.

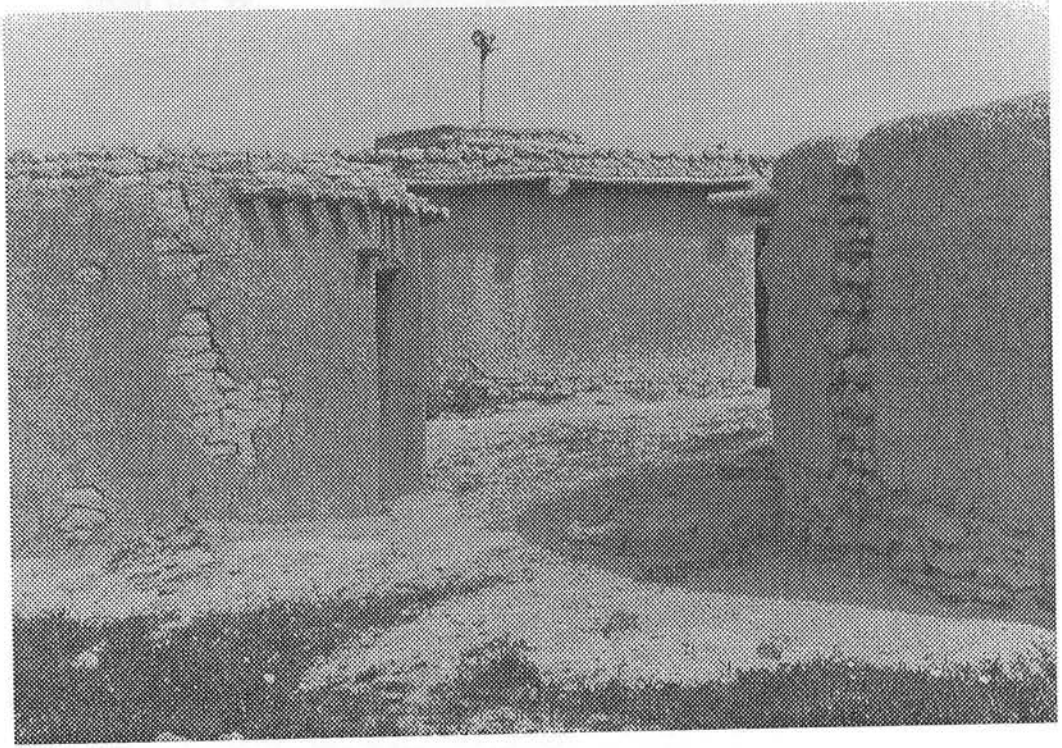
Fig. 122 LEV, 1994 view of RH1-3 showing winter damage.

of the art of render-making, is the need to incorporate an organic element and to work the material continuously over four to eight weeks, longer if time permits. Finely chopped straw is probably the most commonly used material although others are also considered, their use being dictated by local conditions. The long period of maturing and working serves to break down the soil and to allow total hydration and aeration of the mix resulting in the partial decay of the organic additive and the complete restructuring of the clay platelets. Under conditions of long term maturing the decay is total and the natural organic nutrients and elements are released into the mixture bonding with the clay and providing the increased cohesion and water-proofing necessary to make a good quality render. It frequently has the texture and aromatic aura of a very mature dung heap. The evil smelling mixture is then applied to the wall of the building in much the same fashion as modern plastering although in primitive conditions it was usually applied directly by hand (fig. 112). This was applied to a dampened wall and was usually no more than a few centimetres thick as any greater application would separate from the wall and collapse under its own weight. Smoothing or burnishing by hand or with the use of an appropriate tool was then carried out and served to even out the layer and to raise the finer clay particles to the surface which would then become orientated parallel to the surface in thin lamina. It also pushed the clay into the many micro-cracks in the wall forming a greater bond with it. The effect of this would be to provide an immediate and well structured barrier to the exterior of the wall which, under limited to moderate weather conditions would quickly seal against water penetration and present a smooth surface encouraging water run-off. Heavier and more persistent rainfall would, however, lead to the dissolution of the clays and the gradual erosion of the render (fig. 122).
